ONN Monitoring Report:
ACTIVITIES CONTINUE
AT THE ABANDONED 50 MWE REACTOR AT YONGBYON

Veronika Bedenko

Overview of recent activity

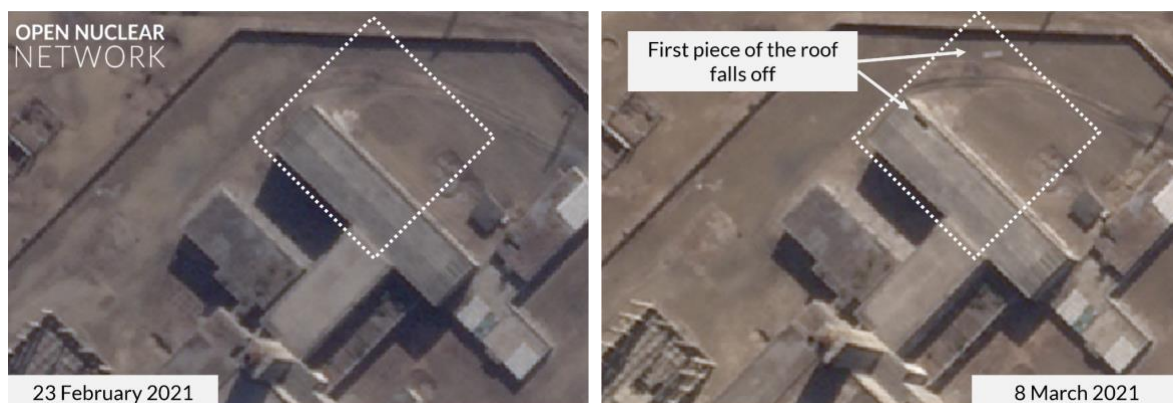
The first changes to the roof of the building in question can be traced back to some time between 23 February and 8 March 2021, when the first piece of roofing was removed or had fallen from the building (see Figure 1). An object of a size and color matching the now absent part of the roof appeared to be placed in close proximity to the building. As no other signs of construction were spotted on the site of the facility at that time, and given that the site had been abandoned for decades and underwent the only visible maintenance 10 years ago,³ it is reasonable to conclude that the change in the roof was likely to have been the result of damage by strong wind or some other natural cause rather than purposeful dismantlement,

Figure 1. Imagery shows that the first change to the roof happened between 23 February and 8 March 2021.

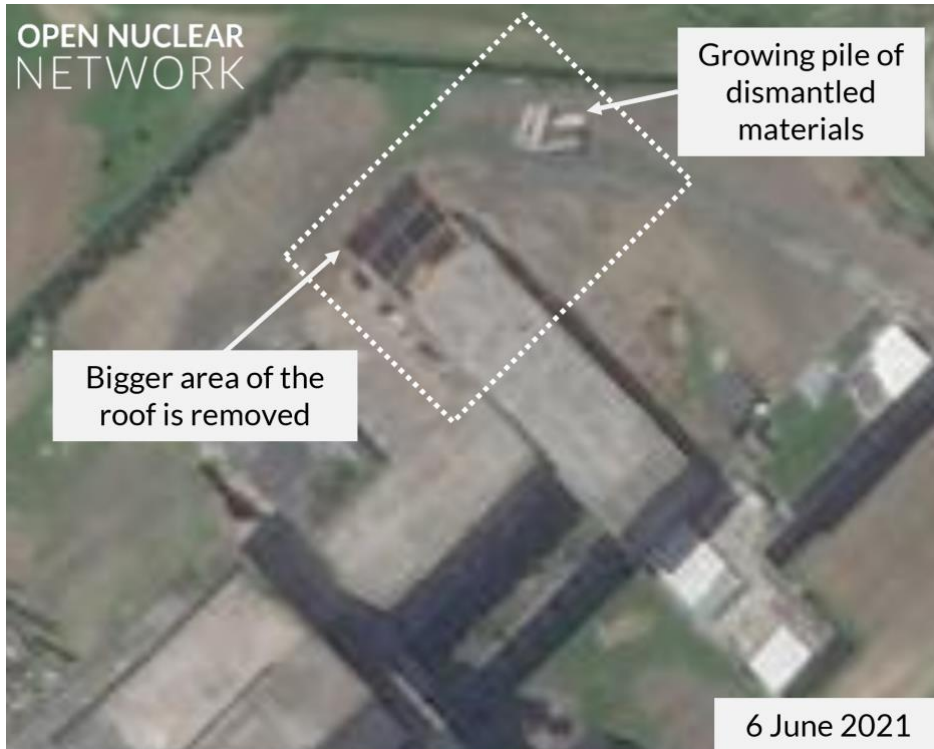
Since the March 2021 change to the roof, the building remained intact, with no significant changes detected until mid-May 2021. Analysis of available high resolution imagery from Planet for the period 13 May to 6 June 2021 indicated that the roof had undergone further modification (see Figure 2). Most likely, the change occurred between 22 and 26 May, as indicated by the 3-meter resolution imagery from Planet. Satellite imagery from 6 June revealed that material removed from the roof had been collected and piled next to the previously removed part, which points to the ongoing dismantlement activity.

Figure 2. Further dismantlement of the roof detected in satellite imagery from 6 June 2021.
 Image © 2021 Planet Labs Inc. All Rights Reserved. Reprinted by permission.

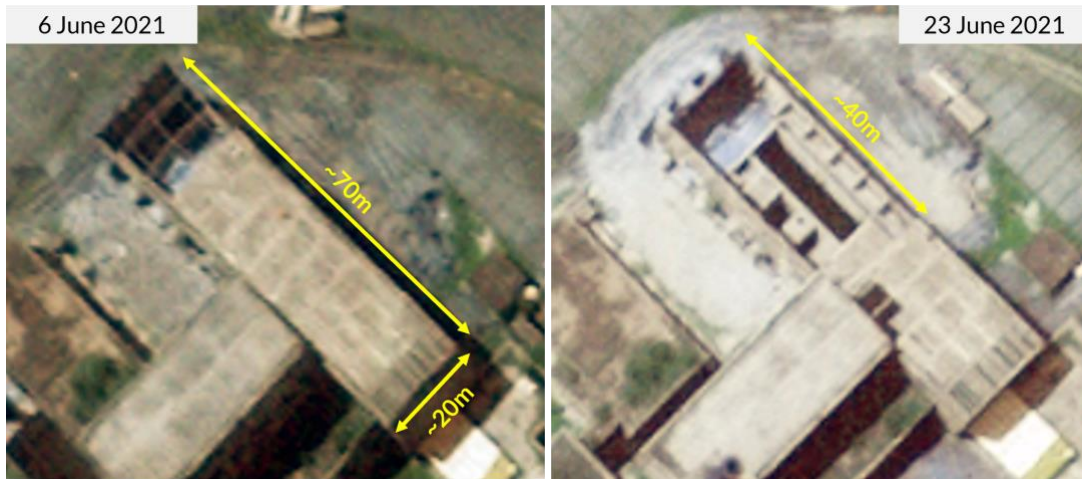
The next significant modification of the roof was seen in Planet imagery from 23 June, as reported in ONN's previous monitoring report. The size of the uncovered part of the building was approximately 40 x 20 meters, revealing a little over half of the inside layout of the building (see Figure 3).

Figure 3. A close-up of the roofless part of the building with approximate measurements.
 Image © 2021 Planet Labs Inc. All Rights Reserved. Reprinted by permission.

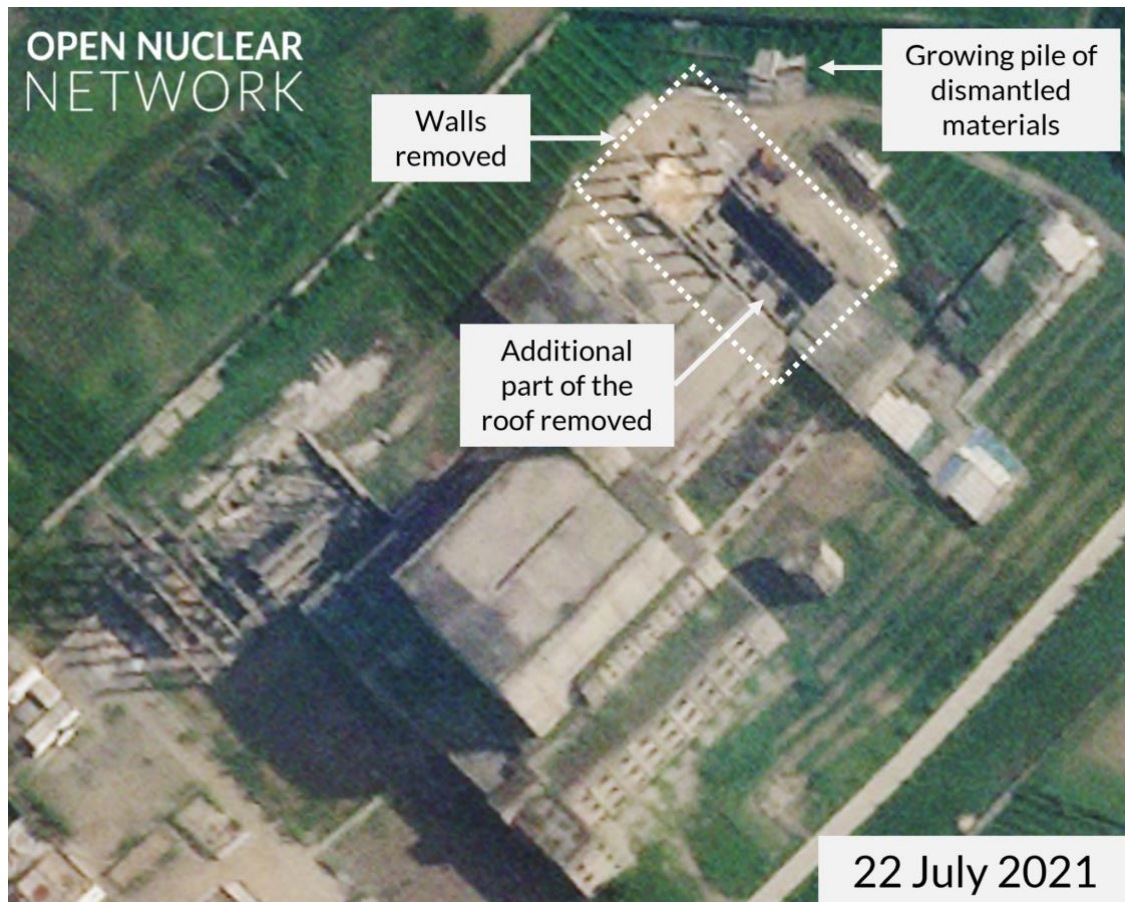
The latest satellite imagery, from 22 July, shows that activity at the site has continued and progressed considerably. Within one month, the roof was dismantled further and the walls of the building were removed (see Figure 4).

Figure 4. Continued dismantlement activities are observed on the satellite imagery from 22 July. Image © 2021 Planet Labs Inc. All Rights Reserved. Reprinted by permission.

The recent changes to the building show clearly that demolition activities have been in progress. The ultimate purpose of these activities still remains unclear.

If the 50 MWe reactor project was truly abandoned, the building would have decayed naturally, which could have triggered the current dismantlement activities. Frank Pabian,⁷ an expert in satellite imagery analysis, added that the dismantlement could have started due to safety considerations:

Since this site has been decommissioned for almost 30 years, I would believe that age and weather has taken its toll, causing the roof to be unstable and, hence, its removal for safety reasons.⁸

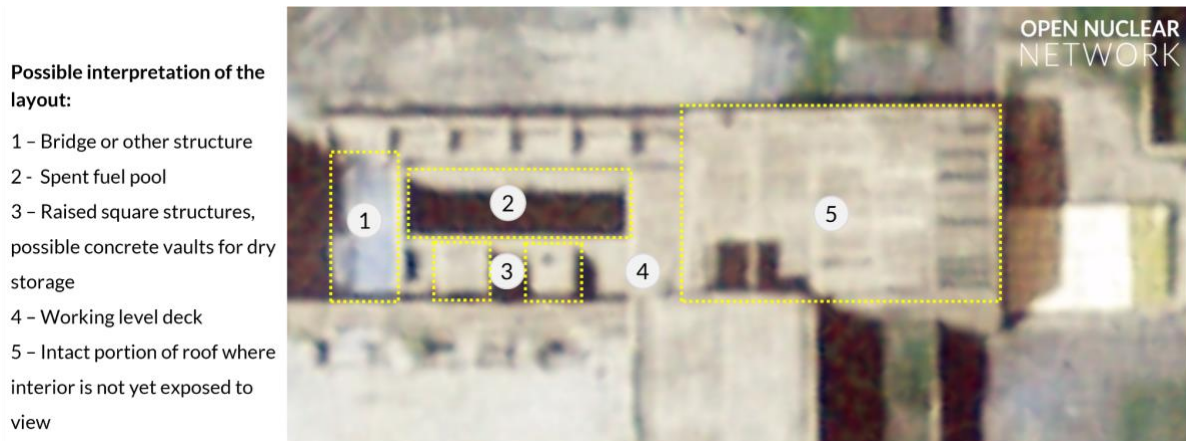
Most of the experts consulted by ONN agreed that the most likely purpose of the building was to serve as storage for spent fuel. One possible interpretation of the interior layout of the building is presented in Figure 5.

Figure 5. One possible interpretation of the interior layout of the building.
Image © 2021 Planet Labs Inc. All Rights Reserved. Reprinted by permission.

While some experts interpreted the layout to be suitable for both wet and dry storage of the spent fuel, one nuclear expert who formerly participated in the 1990s Korean Peninsula Energy Development (KEDO) project added a cautionary note that, when designing a reactor, a spent fuel pond (i.e. wet storage) is normally directly connected to the reactor hall. In the satellite imagery, however, the building in question is not directly adjacent to the reactor hall. In his view, it might be more reasonable to assume that the building would be better suited for dry storage of spent fuel.
