**UPDATE: DEVELOPMENTS  
AT THE DPRK'S PUNGGYE-RI  
NUCLEAR WEAPON TEST  
SITE BETWEEN 24 MARCH  
AND 6 APRIL 2022**

Katsuhisa FURUKAWA, Jaewoo SHIN

6 April 2022

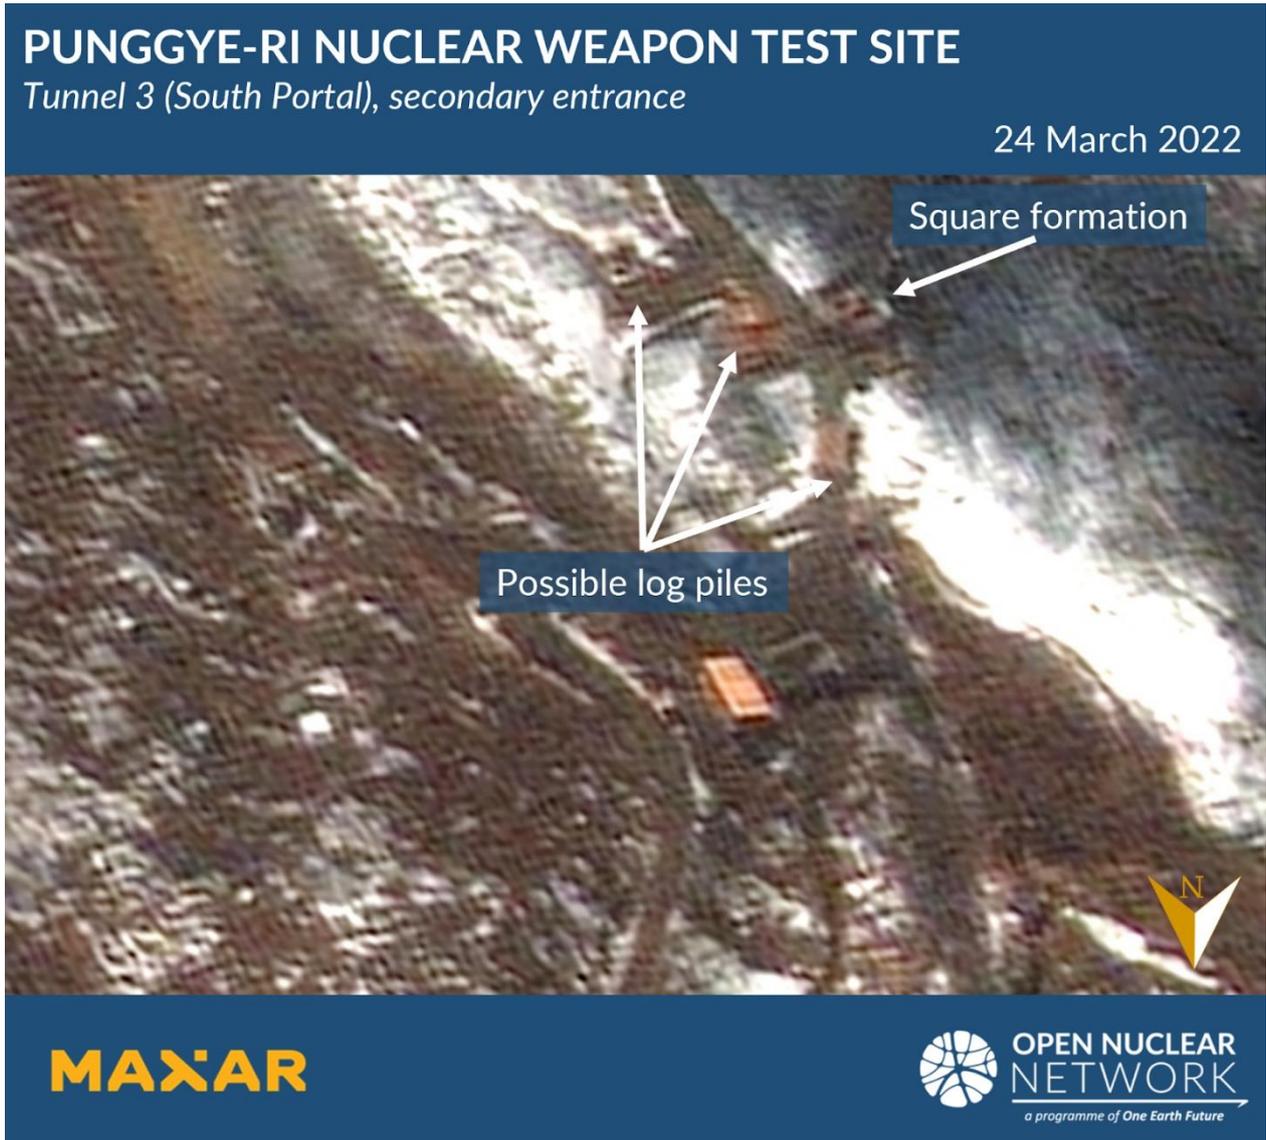
A satellite image from 24 March 2022 shows a square formation visible near the secondary entrance, which is likely related to the excavation of the edge of the mountain at this location (Figure 1). This square formation might be piles of logs for use in restoring the tunnel structure, given that the brown colour of this square formation resembles the colour of possible log piles nearby.

Figure 1. Area near the secondary entrance to Tunnel 3 as of 24 March 2022.  
Image: © 2022 Maxar Technologies. All Rights Reserved. Reprinted by permission.

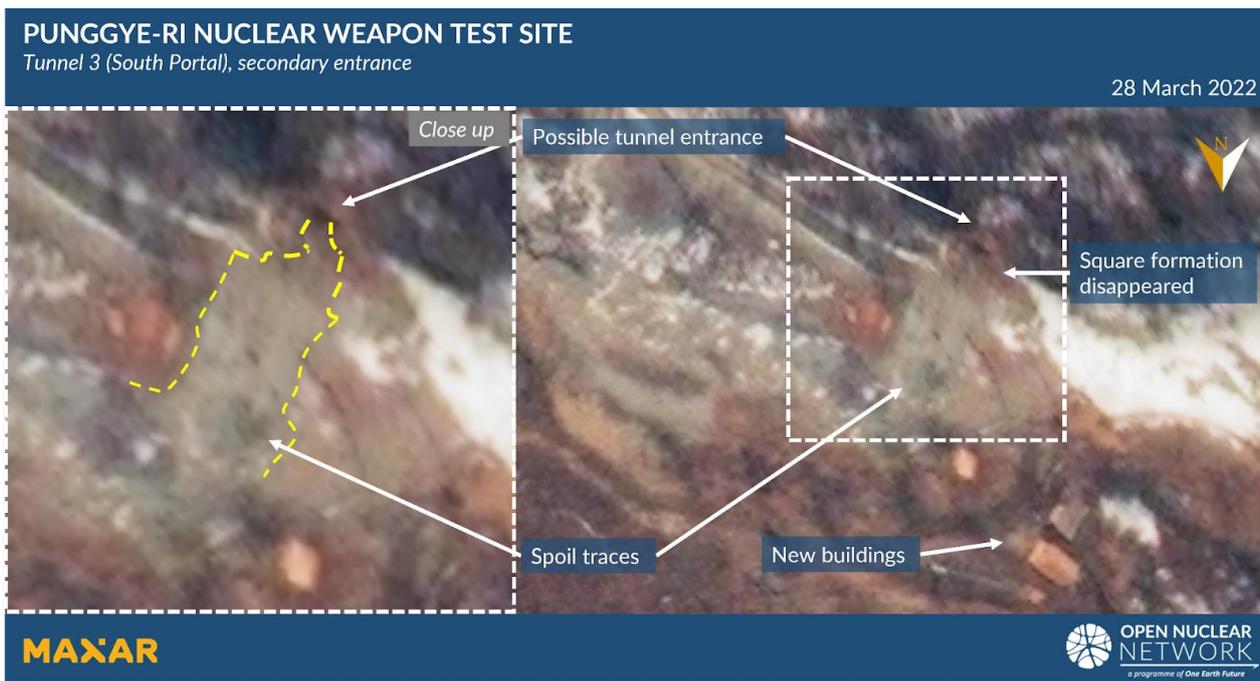
In another satellite image from 28 March 2022, this square formation is no longer visible (Figure 2). Instead, what appears to be a tunnel entrance became newly visible at a location nearby (Figure 2), approximately at the same point as the known former second entrance to Tunnel 3. If the square formation represented piles of logs, these logs could have been transported into this tunnel and used to support its interior structure during excavation.

Traces of spoils stretched from this possible tunnel entrance across the road toward an old spoil pile nearby where a large amount of spoil piles from previous excavations of Tunnel 3 had accumulated (Figure 2). These signs suggest frequent transportation of spoils from the possible tunnel entrance to the old spoil pile nearby.

Figure 2. Area near the secondary entrance to Tunnel 3 as of 28 March 2022.  
Image: © 2022 Maxar Technologies. All Rights Reserved. Reprinted by permission.

Based on these observations, it is assessed that, by 28 March 2022, the DPRK likely established a preliminary entrance to Tunnel 3 and started excavation of the tunnel structure.

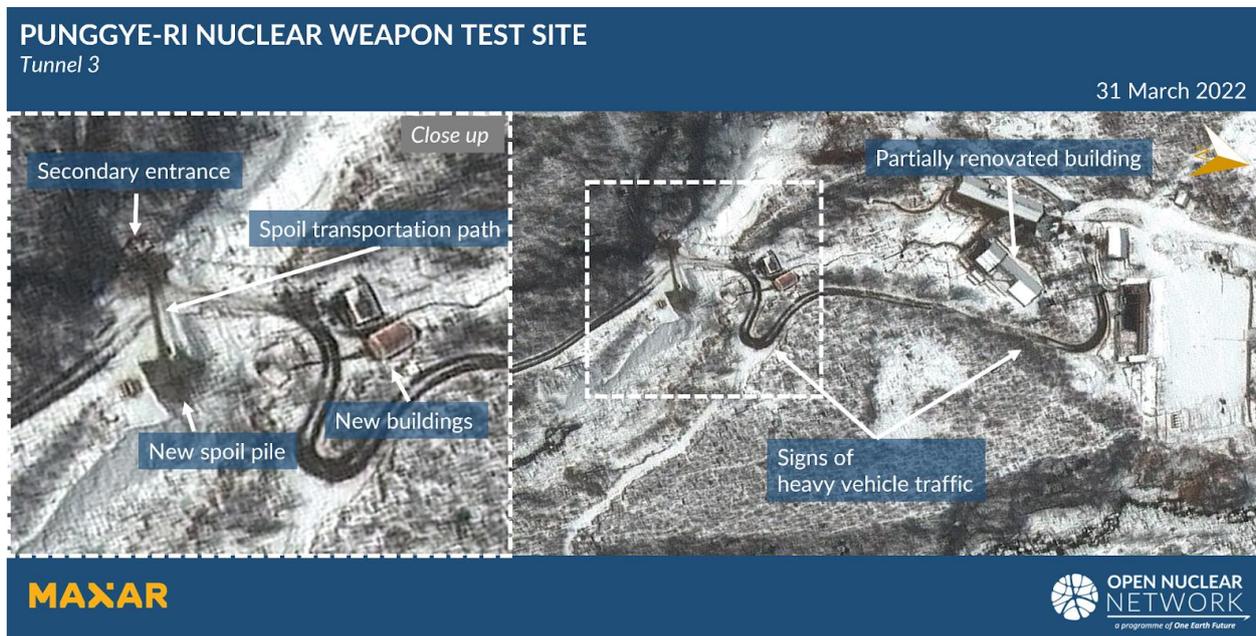
In the satellite image from 31 March 2022, the tunnel entrance became more clearly visible than in previous satellite images (Figure 3). In addition, what appears to be a new spoil pile became visible at a location across the road from this tunnel entrance (Figure 3). A transportation path for the new spoil pile is also visible. The new spoils were likely excavated and transported from this tunnel to this new spoil pile.<sup>4</sup> These signs indicate that, by 31 March 2022, the tunnel entrance was likely completed and the excavation of Tunnel 3 further advanced.

Figure 3. Area near the secondary entrance to Tunnel 3 as of 31 March 2022.  
Image: © 2022 Maxar Technologies. All Rights Reserved. Reprinted by permission.

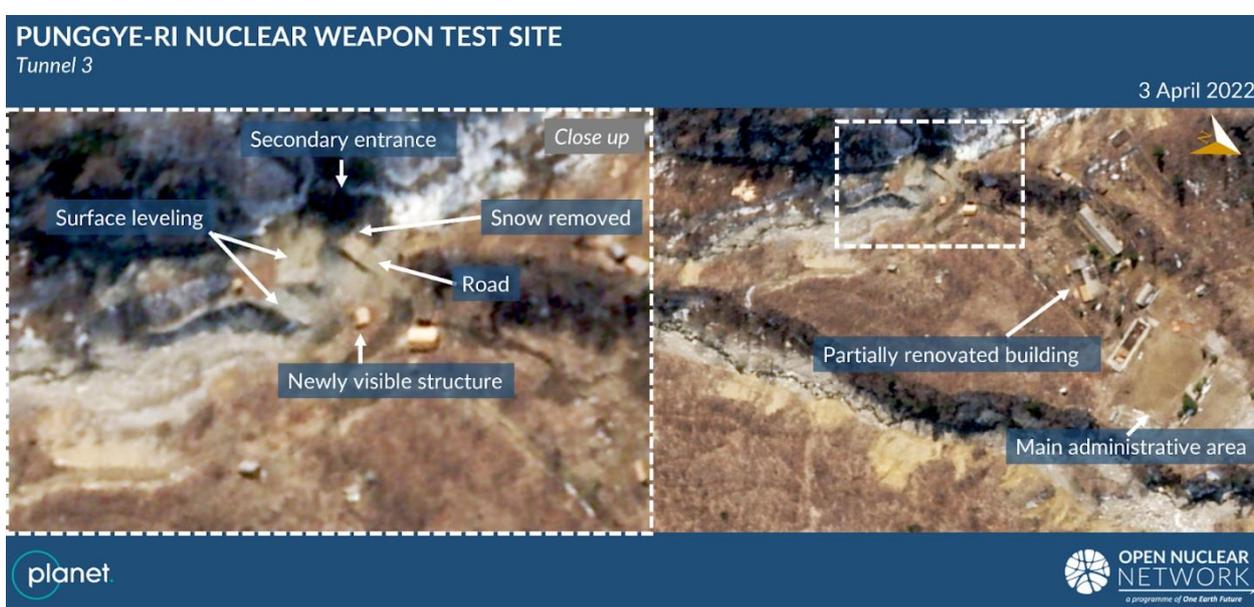
Another satellite image from 3 April 2022 shows that snow was cleared in the area surrounding the tunnel entrance and also shows surface leveling near the spoil pile and on the road leading to this tunnel entrance (Figure 4). These signs suggest continuous transportation of spoils from this tunnel to the spoil pile (Figure 4).

Additionally, on the same satellite image, a newly visible structure, possibly a small building, is present nearby, which is likely

related to the excavation activities because of its proximity to the flattened ground surfaces (Figure 4).

Figure 4. Area near the secondary entrance to Tunnel 3 as of 3 April 2022.  
Image: © 2022 Planet Labs. All Rights Reserved. Reprinted by permission.

These signs suggest steady ongoing progress of the excavation of Tunnel 3.

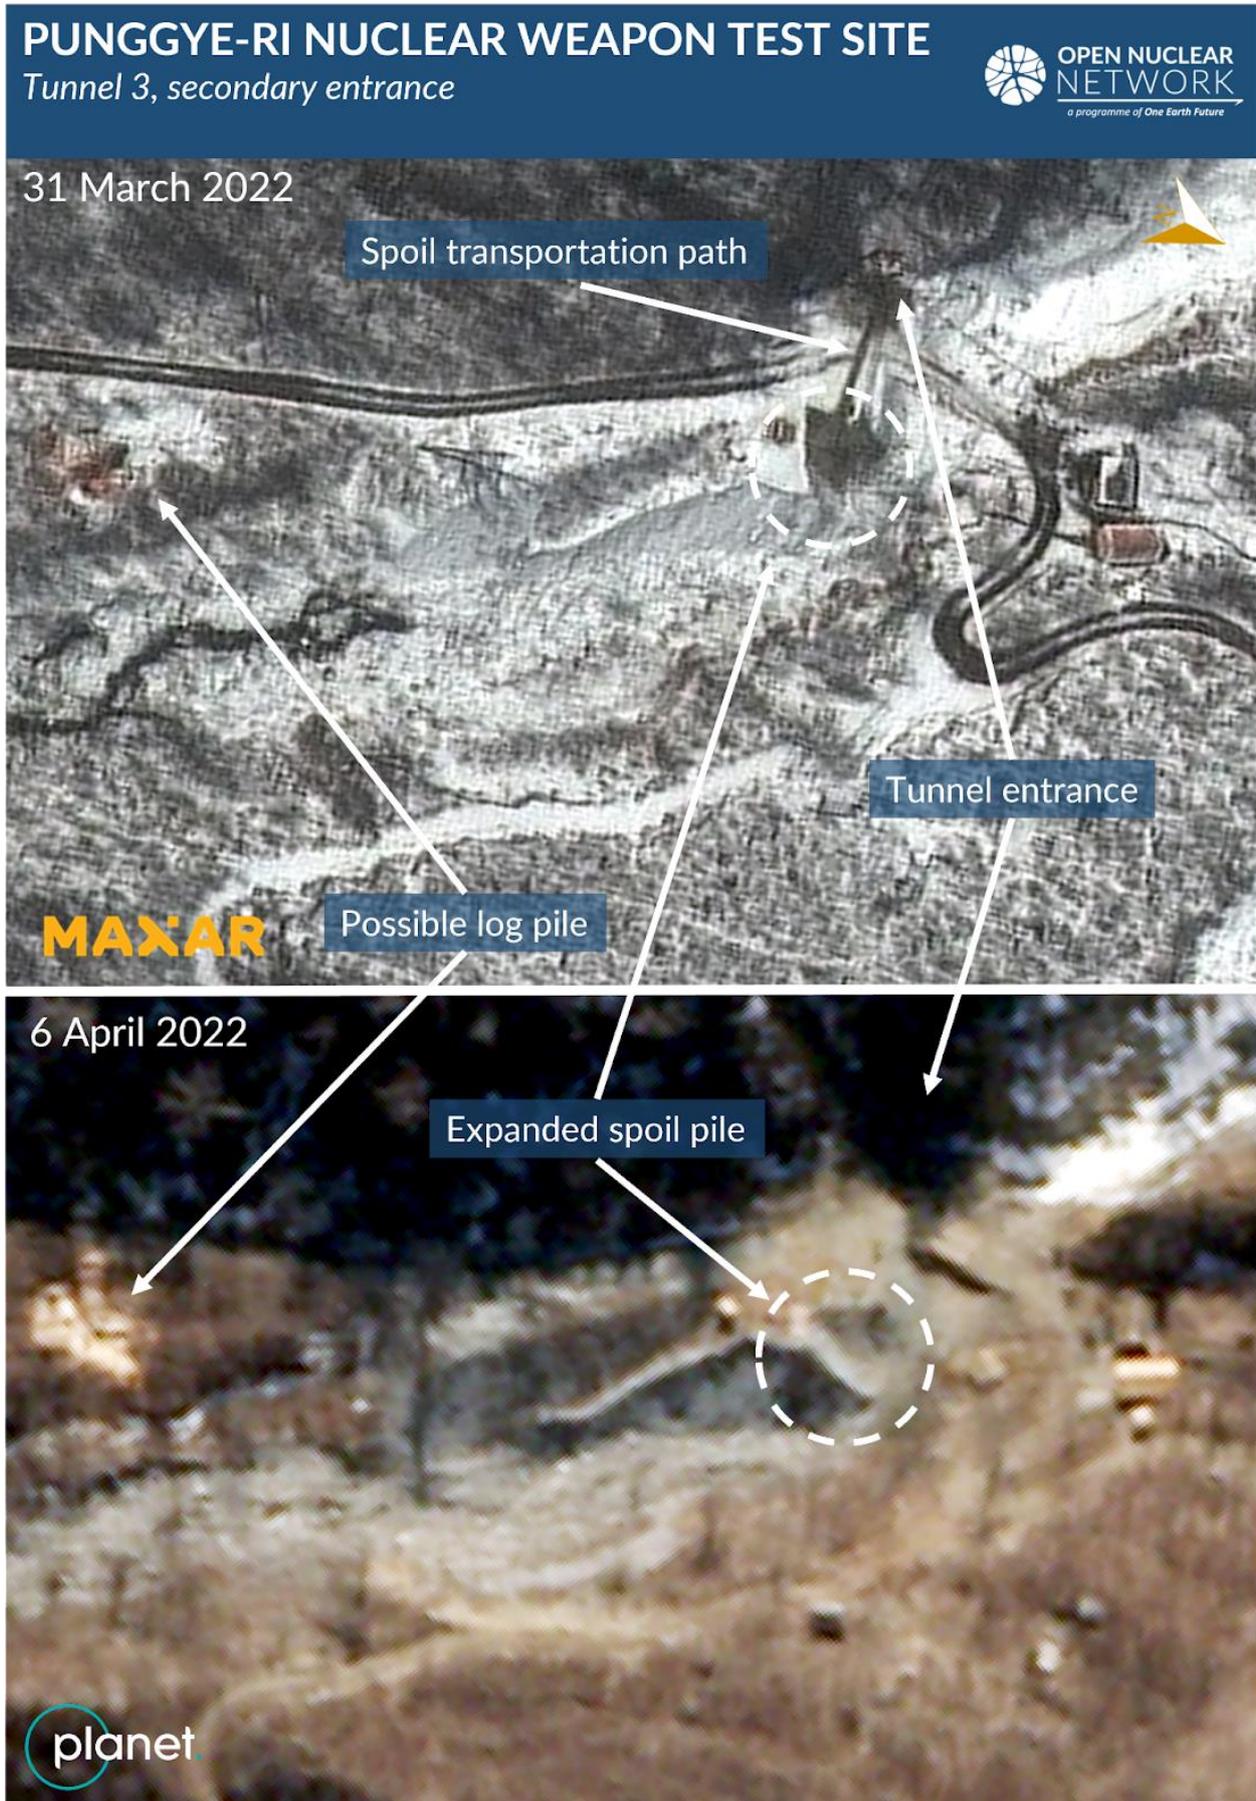
The spoils appear to have been added to the spoil pile, eventually, resulting in the expansion of the size of this spoil pile. Comparison of the satellite images from 31 March and 6 April 2022 show a growth in the spoil pile (Figure 5).

Figure 5. Comparison of the satellite images from 31 March and 6 April 2022 showing the spoil pile near the secondary entrance to Tunnel 3.  
Image: © 2022 Maxar Technologies (top) and Planet Labs (bottom). All Rights Reserved. Reprinted by permission.

These signs suggest continuous progress in the excavation and restoration of Tunnel 3.
